ACCIDENT INVESTIGATION COMMISSION

AIRCRAFT ACCIDENT INVESTIGATION PRELIMINARY REPORT AIC-11-1010

**Forced landing
P2-MCJ
Bombardier DHC- 8-103
33 km south east of Madang
13 October 2011**

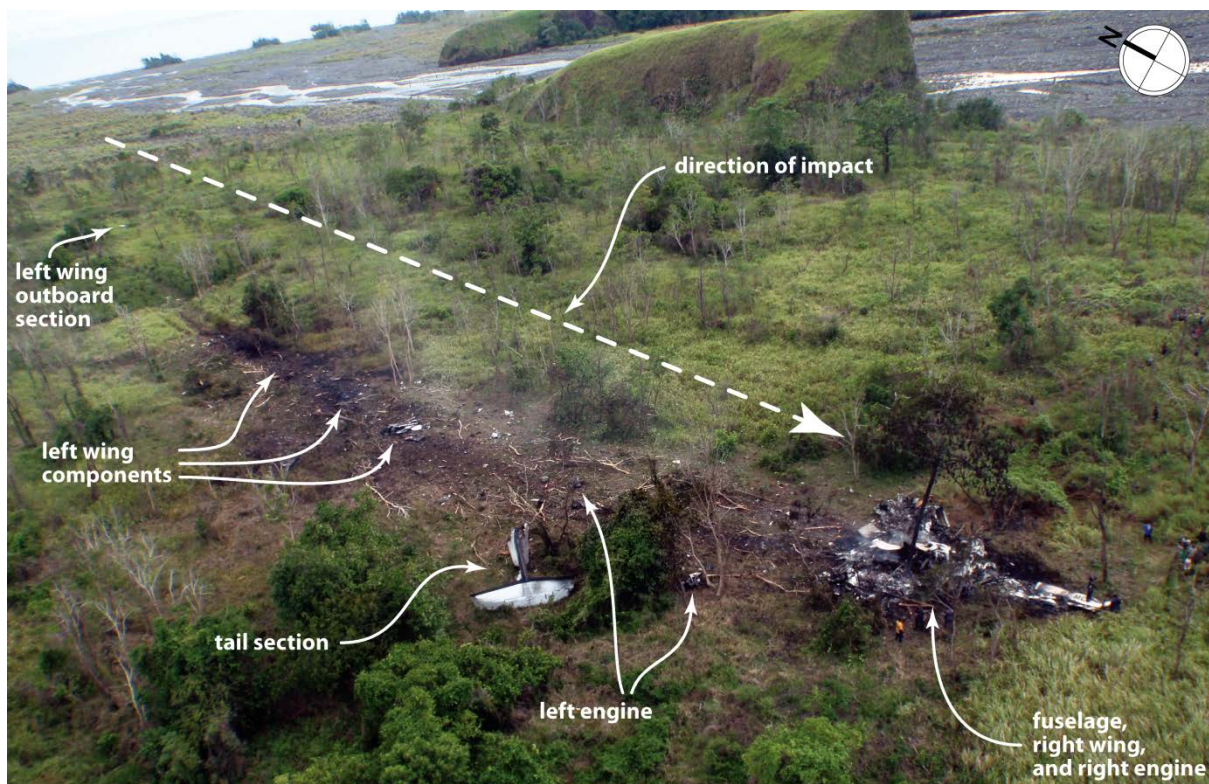
Figure 3: Aircraft wreckage overview

The aircraft impacted sparsely wooded flat and rocky terrain, adjacent and parallel to a river bed. The wreckage trail was approximately 300 m long, oriented on a magnetic bearing of 175 degrees. Evidence from the tree and ground witness marks indicated the aircraft struck the terrain in a controlled state in a shallow angle of descent.

The outboard section of the left wing was located at the beginning of the wreckage trail, followed by numerous other elements of the left wing structure and its components. The left engine sustained a significant impact which separated it into two sections. The empennage (tail section) separated from the fuselage and was found adjacent to the main fuselage section. The remainder of the aircraft, which included the main fuselage, right wing, and right engine were situated at the end of the wreckage trail (Figure 3).

Thermal damage to aircraft parts and foliage indicated that a post-impact fuel-fed fire began when the aircraft was about halfway along the wreckage trail. When the aircraft finally came to rest, the fire intensified and totally consumed most of the aircraft.

On-site examination of the wreckage revealed that the aircraft was configured with the flaps and landing gear in the fully retracted position. Both engines and propellers were examined

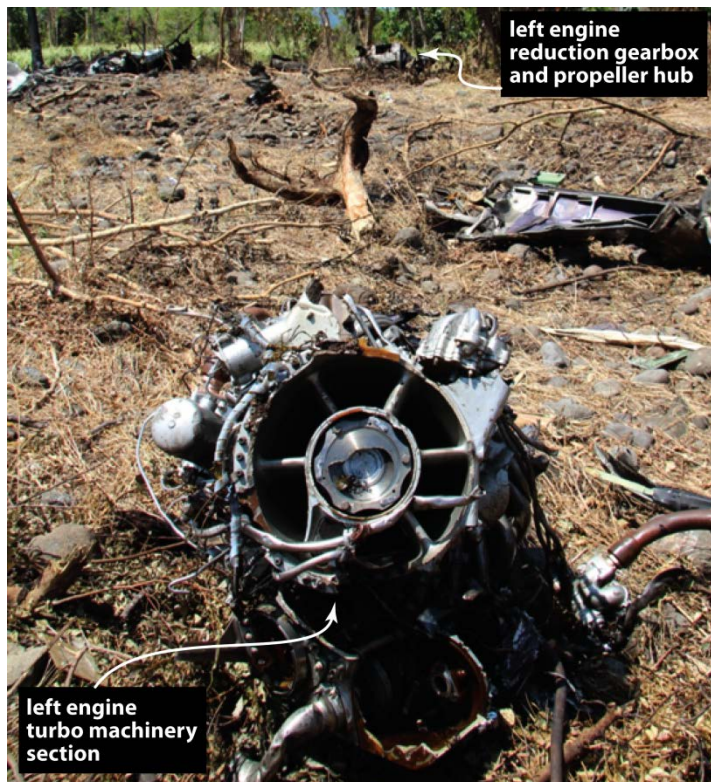
Figure 4: Left engine (after sectioning at the accident site)

externally on-site. The left engine had separated from the left wing and had broken into two sections (Figure 4). The left propeller hub was still attached to the reduction gearbox; however, three of the four propeller blades had separated from the hub during the impact sequence. The left propeller actuator was noted to be in the feathered position, indicated the propeller blade angles at the time of the accident.

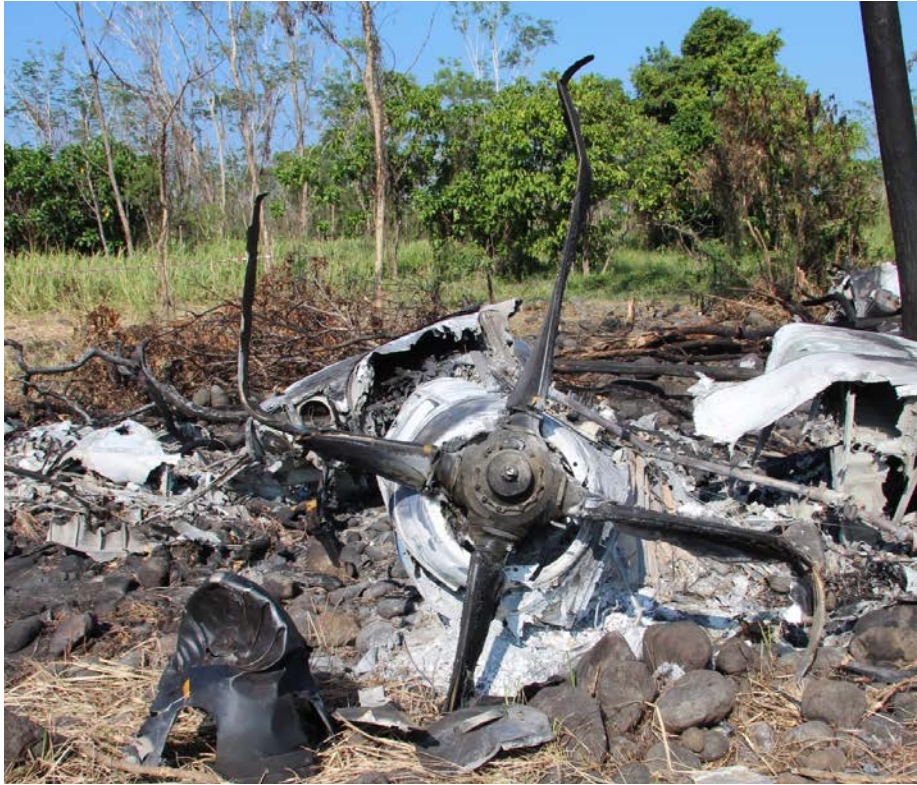
Figure 5: Right engine and propeller assembly

The right engine was still attached to the right wing. It had sustained considerable thermal damage in the post-impact fire. The reduction gearbox outer case had completely disintegrated. The right propeller blades were noted to be in the fully feathered position (Figure 5).
