ACCIDENT INVESTIGATION COMMISSION

AIRCRAFT ACCIDENT INVESTIGATION PRELIMINARY REPORT AIC-11-1010

**Forced landing
P2-MCJ
Bombardier DHC- 8-103
33 km south east of Madang
13 October 2011**

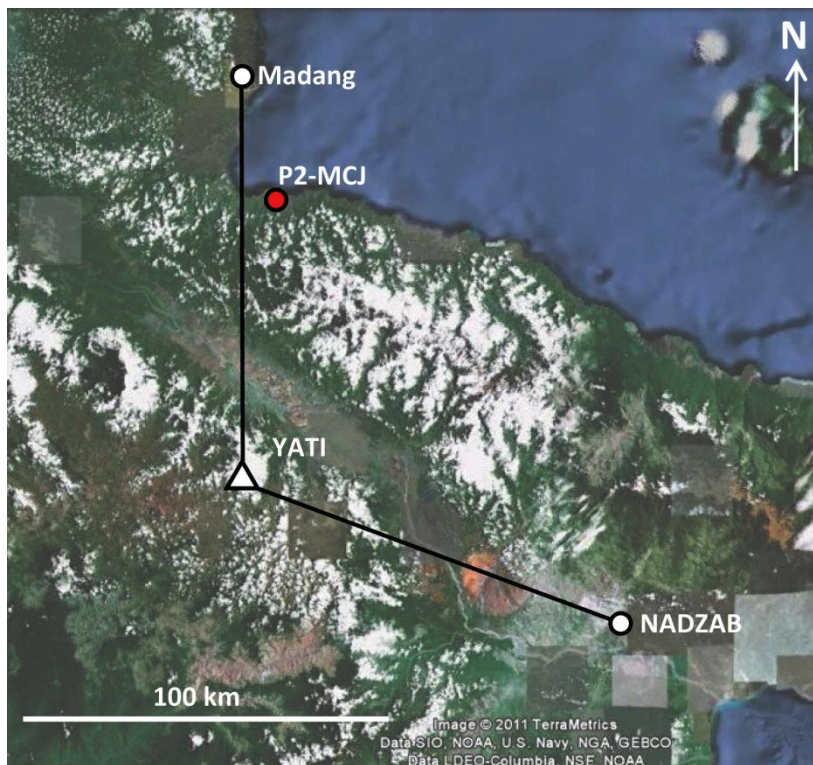
Figure 2: Flight-planned track from NADZAB to Madang and accident site location.

The flight progressed normally and MCJ was transferred to Madang Air Traffic Control (ATC) at 1710 with on descent into Madang. The descent profile on this sector was steep because of the proximity of the Finisterre Ranges to Madang and the pilot-in-command (PIC), who was the handling pilot, was hand-flying the aircraft because the autopilot was unserviceable. He was manoeuvring the aircraft visually to avoid cloud and thunderstorms. At 1712, in response to a request from Madang Tower, the flight crew stated the aircraft was 24 NM from Madang, leaving 13,000 feet on descent.

At approximately 1715, the aircraft's overspeed warning horn sounded. Very shortly afterwards, both propellers simultaneously oversped and exceeded their maximum permitted revolutions per minute (rpm) by in excess of 60 percent. Witnesses on the ground reported hearing a loud 'bang' as this occurred.

At 1717, the crew made a MAYDAY call to ATC and indicated that they were experiencing an in-flight emergency and that both engines had stopped. Madang Tower declared a DISTRESS SAR PHASE, believing the aircraft was about to ditch in the ocean.

The aircraft force-landed on sparsely timbered terrain on the northern side of the Buang River, 33 km south east of Madang township. During the impact sequence, it was severely damaged while colliding with trees and the ground, and an intense fuel-fed fire began.
